MNMM Fatal 2006-03

- Machinery
- February 13, 2006 (Pennsylvania)
- Crushed Stone Operation
- Superintendent
- 25 years old
- 5 years mining experience

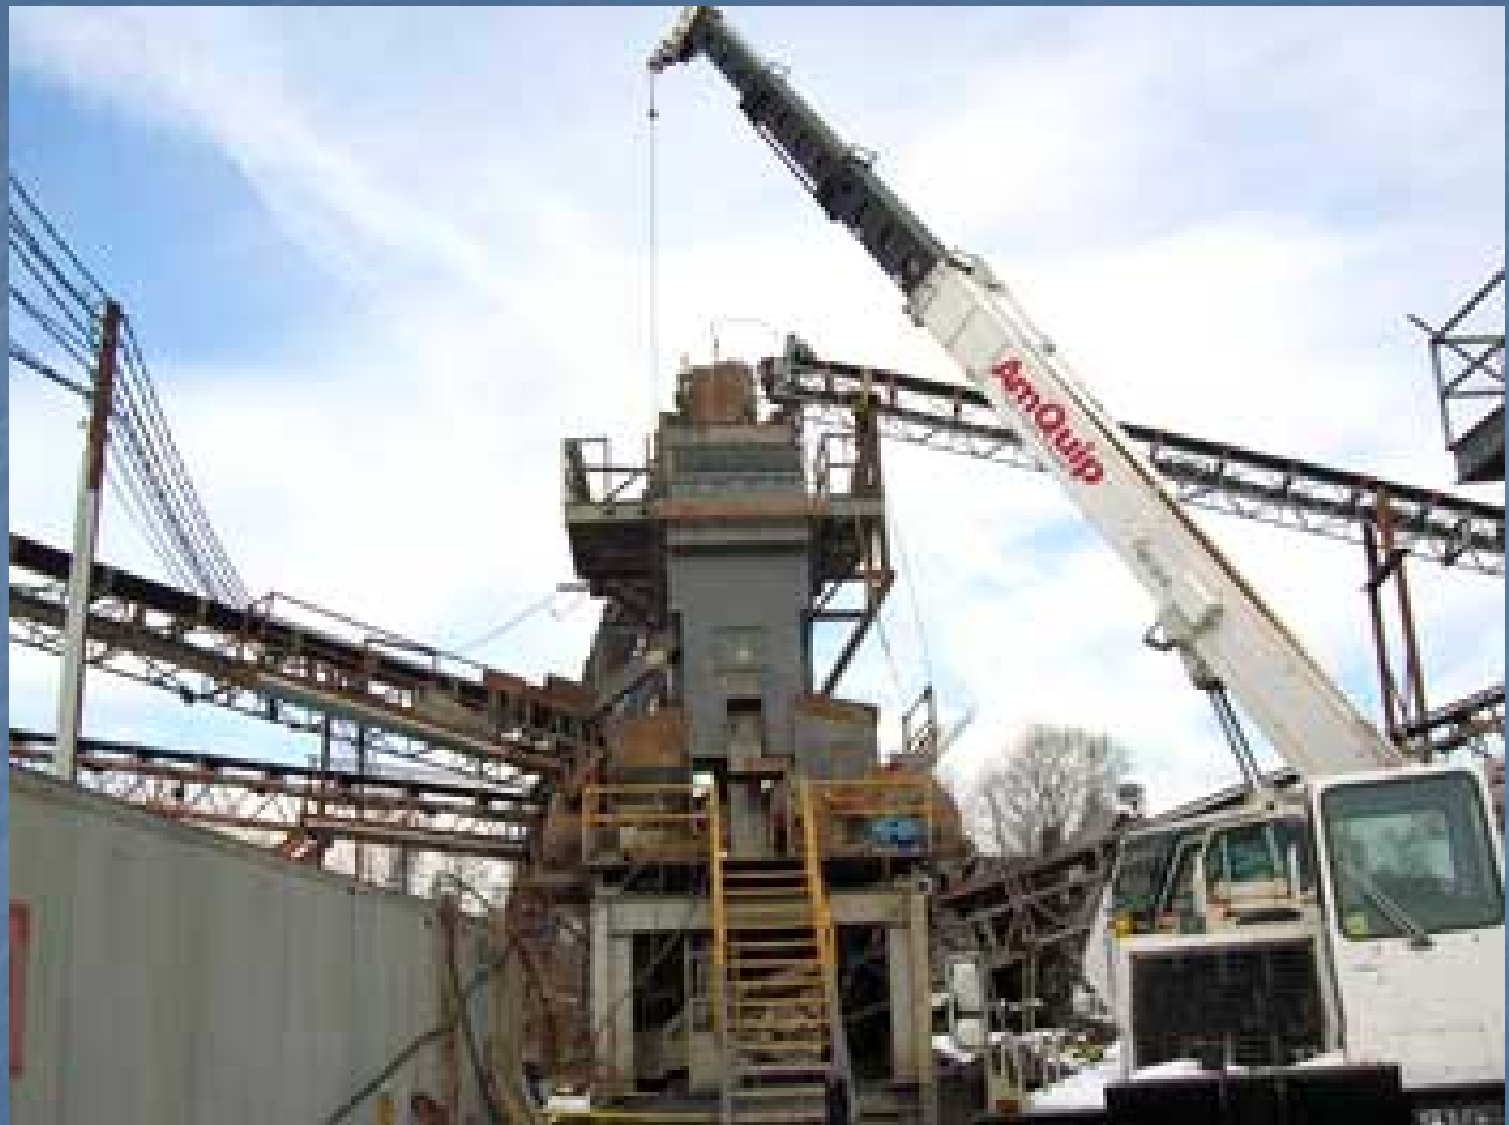
The victim was fatally injured when he was struck by a pitman assembly that was being removed from the crusher at the secondary plant. A crane, operated by a contractor employee, was being used to remove the pitman assembly. The victim was standing on the work platform with two other employees.

- A risk assessment to determine all possible hazards and to establish safe work procedures was not conducted prior to performing the task. No procedures were in place to ensure that persons were clear of suspended loads. The location of the pitman assembly in relation to the upper level screening section catwalk on the crusher prevented a straight, perpendicular, and unrestricted crane pick causing the lifting line to scrape against the upper catwalk.
- Standards and controls were inadequate and failed to ensure that training regarding hand signals was provided to the miners by the contractor's crane operator before performing the task.

- Train miners in safe work procedures, including hand signals, before beginning repairs that involve cranes. Ensure they are familiar with the manufacturer's recommendations.
- Stop, Look, Analyze, and Manage (SLAM) each task to identify all potential hazards before performing work.

- Prior to hoisting loads, crane operators should ensure that all persons are positioned in areas where they will not be exposed to hazards of suspended loads.
- Arrange the rigging to prevent shifting of the load being lifted. Balance the load by placing the crane or hook block directly above the load's center of gravity and ensure the pick line isn't contacting or deflected by any structure.
